**Flood Control Project Maintenance
Levee Inspections**
LMA District Cover Sheet
Spring 2010 Levee Inspection Results

Sacramento River West Side Levee District

Levee Inspection Report By Mile - Spring 2010

| Waterway | | | | | | Bank | Unit Miles | Inspection Start/End | Inspector |
|---|--|--|--|--|--|---|---|---|---|
| Unit No. 01 Sacramento River | | | | | | Right | 50.21 | 05/24/2010 05/26/2010 | John Williamson |

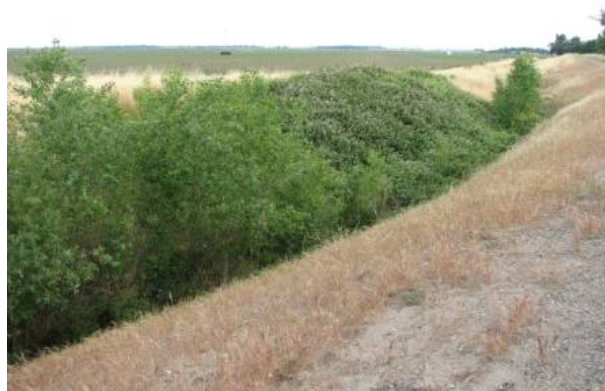
| Levee Mile Report Line | 3 |

| LMR No | Levee Mile | | Category | Item | Location | Rating | Action/Comment | GPS Latitude/Longitude | | Issue No. Photo |
|---|---|---|---|---|---|---|--|---|---|---|
| 3 | 0.98 | 0.98 | Earthen Levee | Vegetation | LS | M | Remove the wild growth other than native grasses from the levee slopes. | 38.812727 ° -121.724496 ° | 38.812727 ° -121.724496 ° | 6 Y |

| trees and berries | |

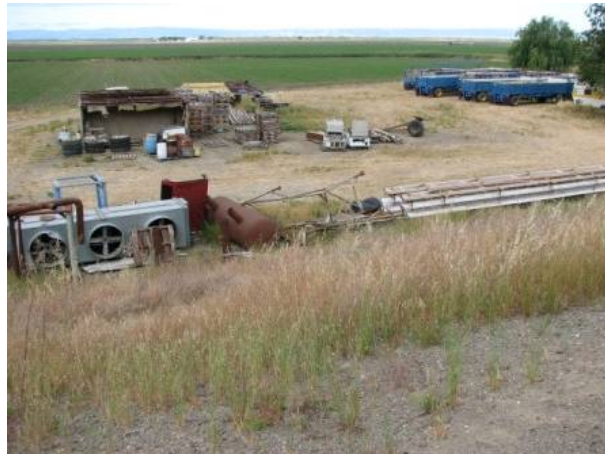
| Levee Mile Report Line | 4 |

| LMR No | Levee Mile | | Category | Item | Location | Rating | Action/Comment | GPS Latitude/Longitude | | Issue No. Photo |
|---|---|---|---|---|---|---|--|---|---|---|
| 4 | 2.44 | 2.44 | Earthen Levee | Encroachments | LS | M | Equipment | 38.832537 ° -121.729542 ° | 38.832537 ° -121.729542 ° | 3 Y |

| equipment within the easement | |

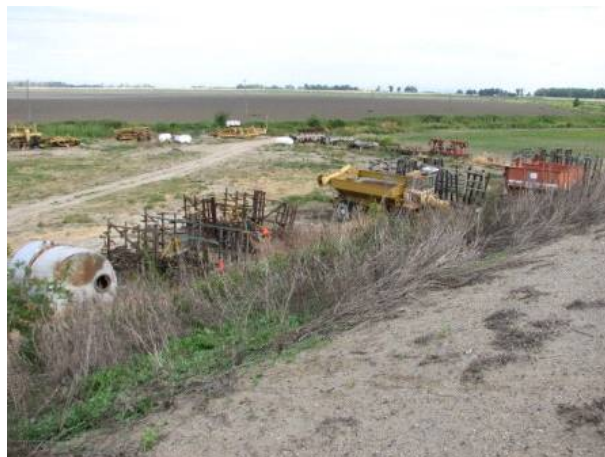
| Levee Mile Report Line | 6 |

| LMR No | Levee Mile | | Category | Item | Location | Rating | Action/Comment | GPS Latitude/Longitude | | Issue No. Photo |
|---|---|---|---|---|---|---|--|---|---|---|
| 6 | 3.02 | 3.02 | Earthen Levee | Encroachments | LS | M | Equipment | 38.840057 ° -121.731012 ° | 38.840057 ° -121.731012 ° | 5 Y |

| along toe | |

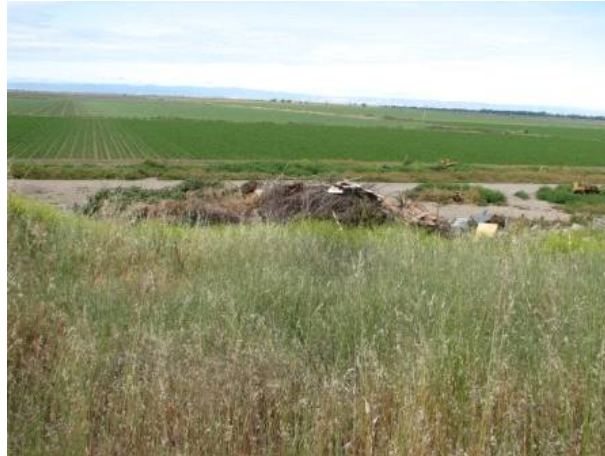
| Levee Mile Report Line | 8 |

| LMR No | Levee Mile | | Category | Item | Location | Rating | Action/Comment | GPS Latitude/Longitude | | Issue No. Photo |
|---|---|---|---|---|---|---|--|---|---|---|
| 8 | 4.66 | 4.66 | Earthen Levee | Encroachments | LS | M | Debris | 38.857245 ° -121.731100 ° | 38.857245 ° -121.731100 ° | 7 Y |

| debris at toe also pile of concrete debris | |

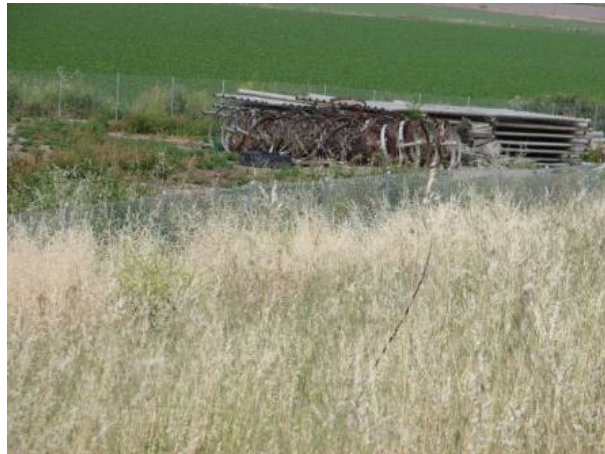
| Levee Mile Report Line | 9 |

| LMR No | Levee Mile | | Category | Item | Location | Rating | Action/Comment | GPS Latitude/Longitude | | Issue No. Photo |
|---|---|---|---|---|---|---|--|---|---|---|
| 9 | 4.85 | 4.85 | Earthen Levee | Encroachments | LS | PO | Fences Inspector Comments: chain link fence runs along levee | 38.859419 ° -121.732708 ° | 38.859419 ° -121.732708 ° | 9 Y |

| chain link fence along toe | |

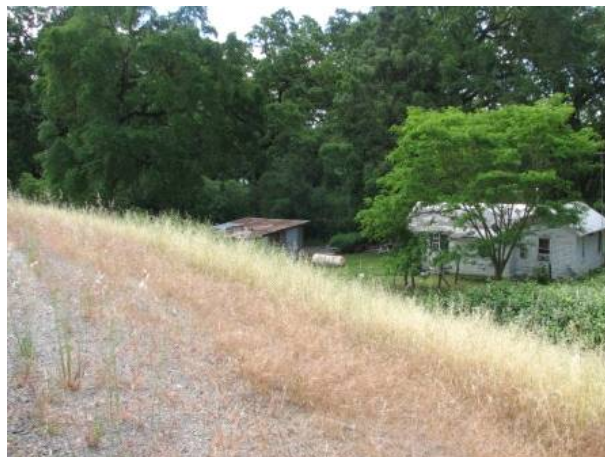
| Levee Mile Report Line | 11 |

| LMR No | Levee Mile | | Category | Item | Location | Rating | Action/Comment | GPS Latitude/Longitude | | Issue No. Photo |
|---|---|---|---|---|---|---|--|---|---|---|
| 11 | 8.87 | 8.87 | Earthen Levee | Encroachments | LS | PO | Buildings | 38.855498 ° -121.783998 ° | 38.855498 ° -121.783998 ° | 11 Y |

| out building is within the easement | |

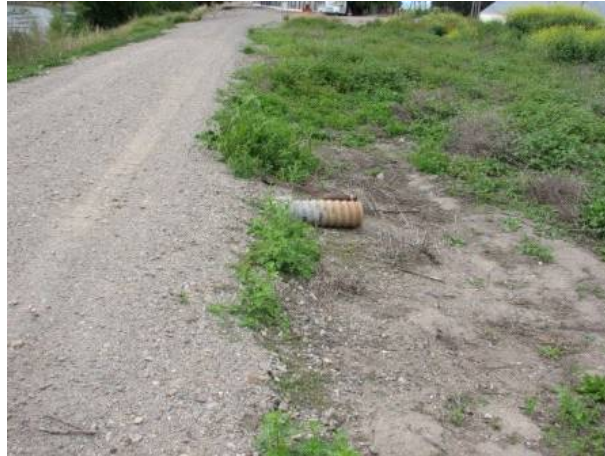
| LMR No | Levee Mile | | Category | Item | Location | Rating | Action/Comment | GPS Latitude/Longitude | | Issue No. Photo |
|---|---|---|---|---|---|---|---|---|---|---|
| 18 | 12.41 | 12.41 | Earthen Levee | Encroachments | CR | M | Pipe Inspector Comments: drain pipe runs thru levee | 38.884497 ° -121.817142 ° | 38.884497 ° -121.817142 ° | 13 Y |

landside view of drain pipe

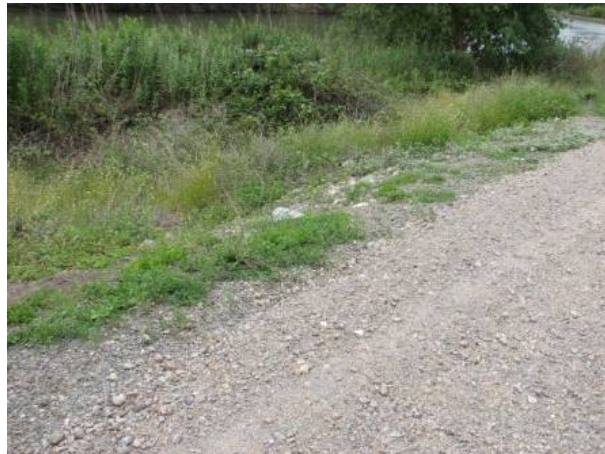
| Levee Mile Report Line | 18 |

waterside view of pipe

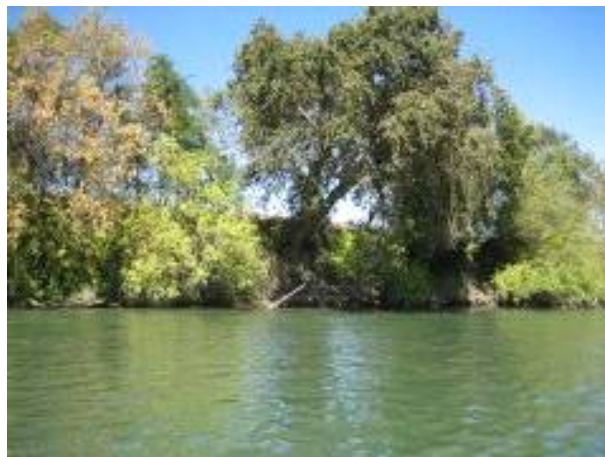
| Levee Mile Report Line | 46 |

| Waterway | | | | | | Bank | Unit Miles | Inspection Start/End | Inspector | |
|---|---|---|---|---|---|---|--|---|---|---|
| 46 | 26.06 | 26.22 | Supplemental Survey | USACE Erosion | WS | M | Inspector Comments: 2009: 10 ft berm, 1:1 slope, tree hazards and holes, clays and silts, 4.64 ft/s [2009 SiteID:SAC_118-0_R] | 39.016400 ° -121.824231 ° | 39.014500 ° -121.825881 ° | 49 Y |

2009: 10 ft berm, 1:1 slope, tree hazards and holes, clays and silts, 4.64 ft/s [2009
SiteID:SAC_118-0_R]

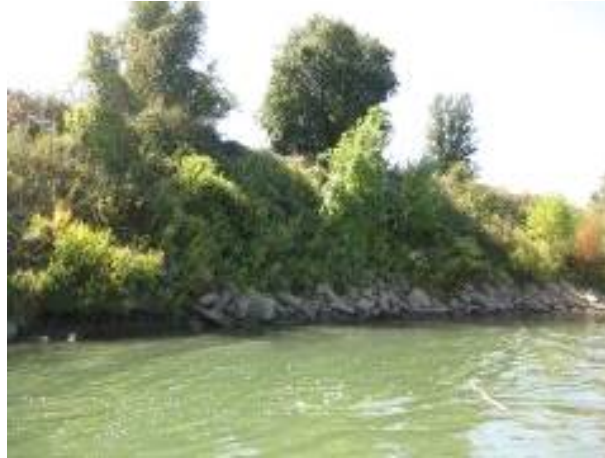
| Waterway | | | | | | Bank | Unit Miles | Inspection Start/End | Inspector | |
|---|---|---|---|---|---|---|--|---|---|---|
| 50 | 31.81 | 31.83 | Supplemental Survey | USACE Erosion | WS | M | Inspector Comments: 2009: 15 ft berm, vertical slope, no stability issues, clays and silts, 5.3 ft/s [2009 SiteID:SAC_123-7_R] | 39.066900 ° -121.867322 ° | 39.067003 ° -121.866914 ° | 50 Y |

| 2009: 15 ft berm, vertical slope, no stability issues, clays and silts, 5.3 ft/s [2009 SiteID:SAC_123-7_R] | |
